# **Roof Review Packet**

Sample Report (identifying details removed)

**Prepared by Scope Guardian**

Inspection: Month 1

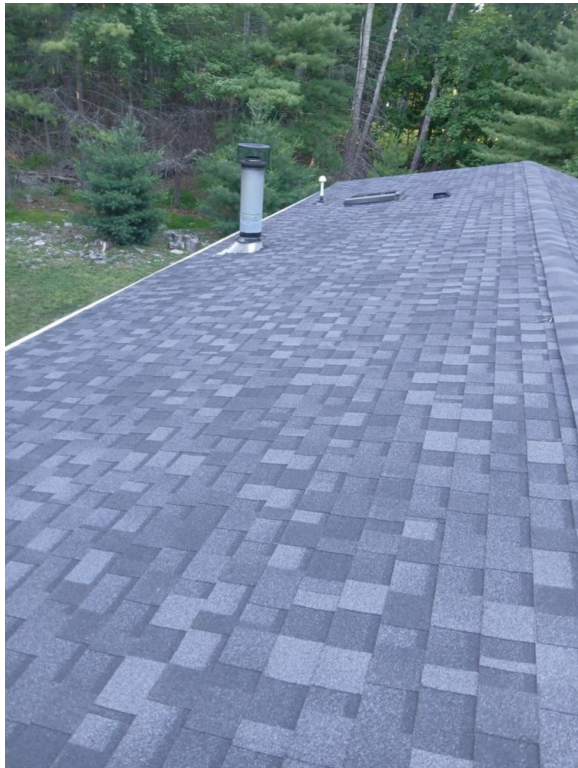
**Plate 1 Penetration location**

The chimney and flue pipe penetration sits low on the slope near the eave. The whole slope above drains toward it.

The base relies on surface roofing cement, and there are fasteners in locations not expected on a correct installation. On a roof about one year old, it is not clear why cement was necessary. The penetration sits low on the slope near the eave, so the whole slope drains toward it.

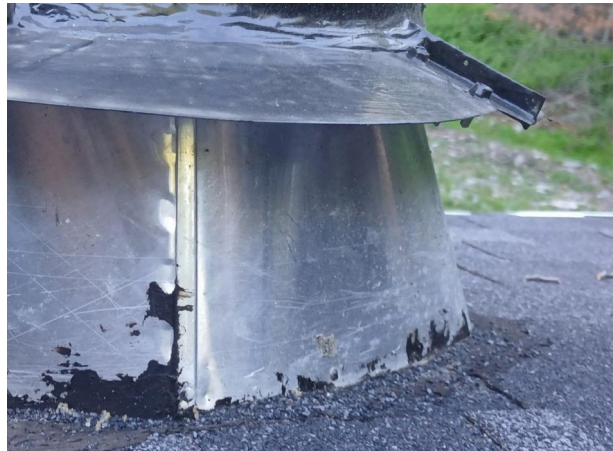
**Plate 2 Flashing seam faces up the slope**

The flashing is a shaped, tapered metal flashing with a vertical lapped seam. The seam faces up the slope, toward the oncoming runoff. On a flashing shaped to shed water the seam should face down the slope. Roofing cement is smeared where the flashing meets the shingles. By the correct method the shingles lap over the upper edge of the flashing.

The flashing at this penetration is a shaped, tapered metal flashing with a vertical lapped seam. The seam faces up the slope, toward the oncoming runoff. On a flashing shaped to shed water the seam should face down the slope, so here it is reversed.

At the up-slope side, the shingles were cut and the area was patched with surface roofing cement rather than the shingles lapping over the upper edge of the flashing, as the correct method requires. The storm collar above is tight and the owner has sealed it, so the collar is not the leak path. The flashing beneath the collar is not sealed, and that joint has no sealant. This is where water and ice reach the pipe.

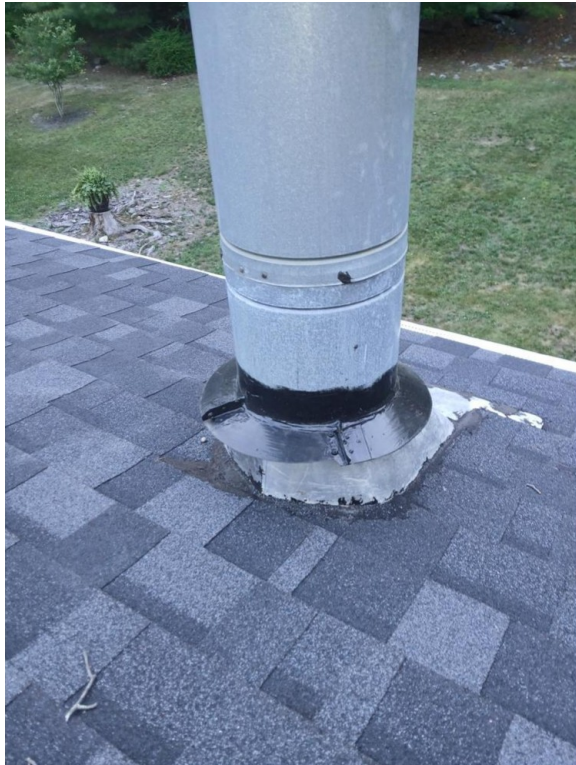
**Plate 3 Base relies on surface cement**

The base relies on surface roofing cement, smeared on the shingles beside the flashing and around its base, instead of the shingles lapping over the upper edge of the flashing.

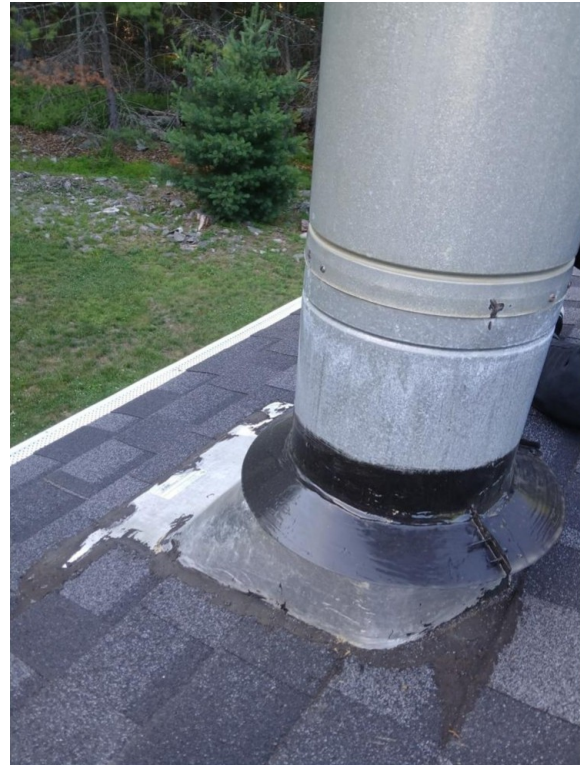
**Plate 4 Collar tight, flashing beneath unsealed**

The storm collar is tight and owner sealed, so it is not the leak path. The joint at the flashing beneath the collar is unsealed, and the base relies on surface roofing cement. Water and ice reach the pipe at the unsealed flashing beneath the collar.

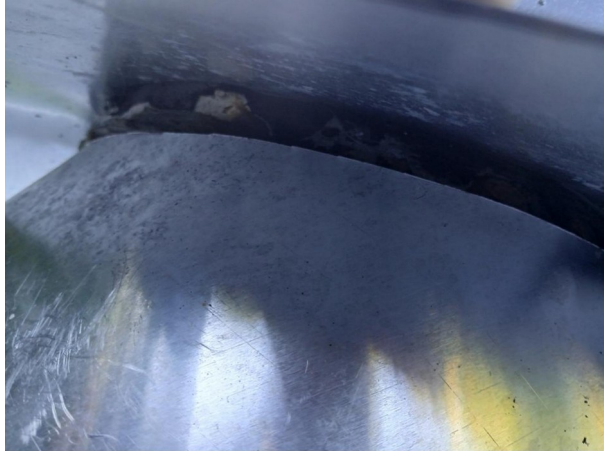
**Plate 5 Unsealed flashing joint beneath the collar**

The flashing joint beneath the collar has no sealant. The collar above is sealed; the flashing is not. This is where water and ice reach the pipe.

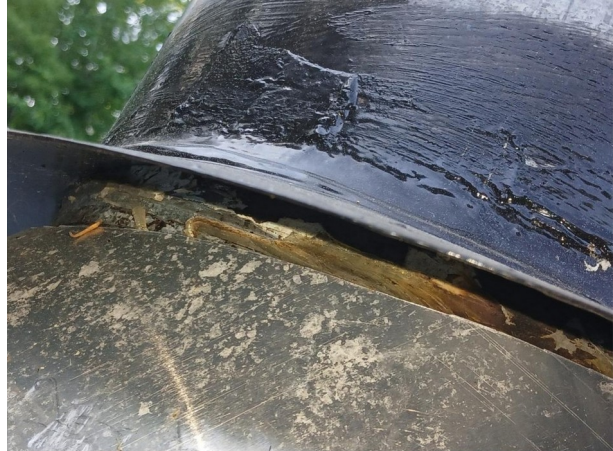
**Plate 6 Unsealed flashing joint, close view**

Close view of the unsealed flashing joint beneath the collar. No sealant is present along this joint.

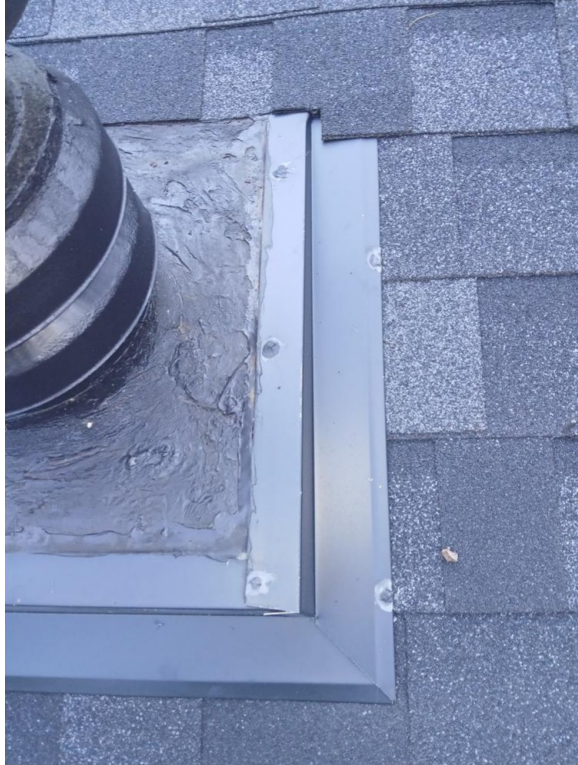
**Plate 7 Second penetration on top of the shingles**

A separate penetration is flashed with a square metal pan and trim that sit on top of the finished shingles, fastened through the face and sealed with caulk. The pan and trim resemble a skylight curb flashing, which is not the intended application for a pipe penetration. By the correct method the flashing would be integrated into the courses with the upper edge under the shingles and the fasteners concealed.

A second, separate penetration, a smaller black corrugated pipe, is flashed with a square metal pan and trim that sit on top of the finished shingles (Plates 7 and 8). The trim is fastened through its face, in the water path, and sealed with caulk. By the correct method, the flashing would be integrated into the shingle courses with its upper edge under the shingles and the fasteners concealed. The documents do not identify the product, and the photographs do not show whether ice and water membrane and integrated flashing are present beneath the trim.

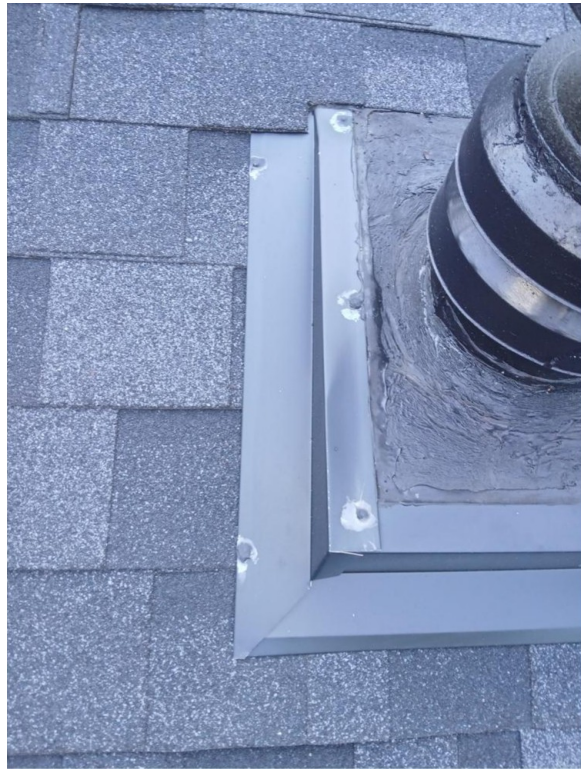
**Plate 8 Second penetration, fasteners through the apron**

The same penetration. The fasteners pass through the trim apron that laps the shingles, each sealed with caulk.

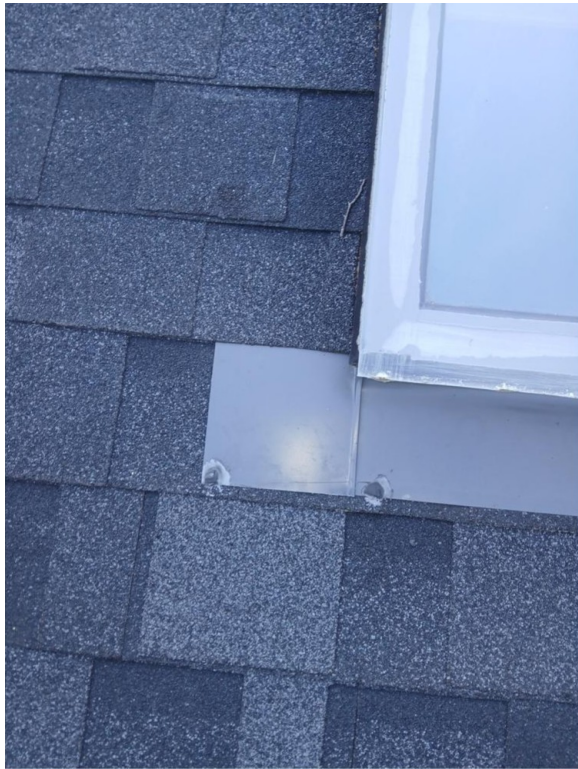
**Plate 9 Skylight flashing, fasteners and lifted shingle**

The skylight flashing shows exposed fasteners and a shingle edge that appears lifted. The contractor replaced the skylight flashing kits with the roof work.

The contractor did not replace the skylights but replaced the skylight flashing kits with the roof work, so this flashing is within the contracted scope. The flashing shows an exposed fastener through the metal side flashing and a shingle edge that appears lifted, which can let ice backup travel under the flashing. The flashing kit product is not identified in the documents.

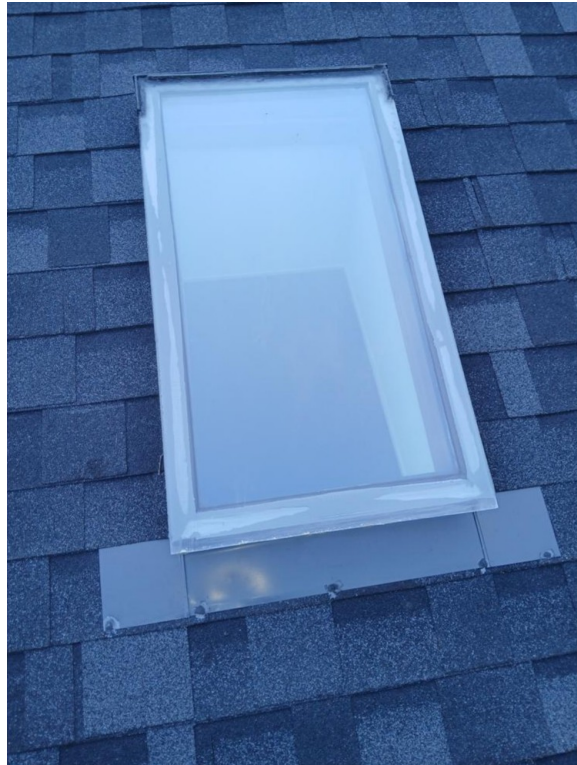
**Plate 10 Skylight apron, exposed fasteners**

Exposed fasteners pass through the metal apron flashing below the skylight.
